FACT SHEET

ORCHARDS

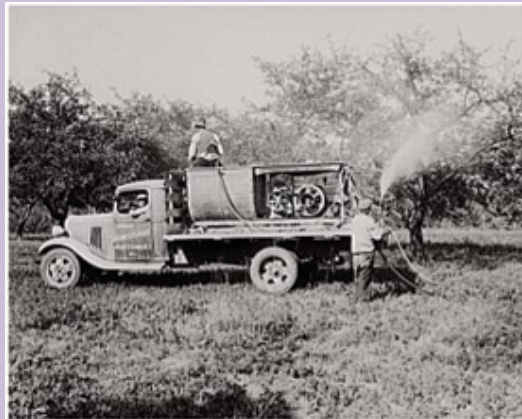
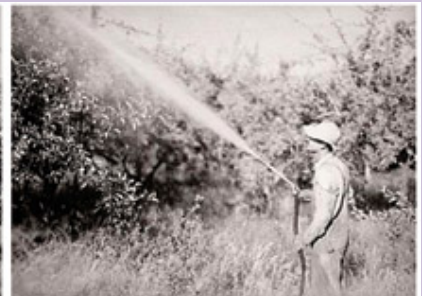
They sprayed, you pay? Spraying of arsenical pesticides on apple orchards was routine from the late 1800s through the 1940s. Lead arsenate was not banned, however, until 1988. images: Library of Congress
